Retrofitting the Old Bridge of Dezful

The objective of the study is the proposing of a method for the retrofitting of the structure of the old bridge in the city of Dezful using a descriptive analytical approach. In order to develop such an approach a vast library research was conducted and various resources reviewed. The old bridge of Dezful is one of the few remaining ancient structures in existence which was constructed in the late Sassanid era and which reflects the local and traditional forms of the city. Using local materials, the ancient architects of the bridge have sought to create an aesthetic and durable structure which has remained in place after more than 1,700 years. The focus of the study is however on the retrofitting of this ancient structure in the city of Dezful and the sustaining of it for future generations of architectural engineers.

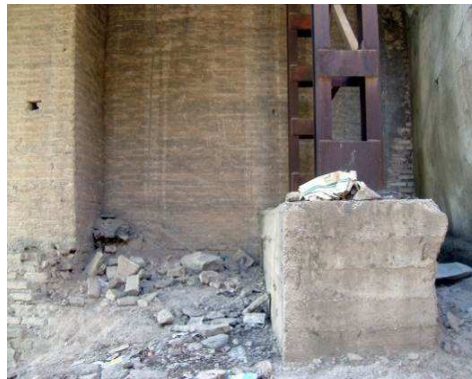
Fig. 6 Installing of a steel structure on the flow breaker(2015)

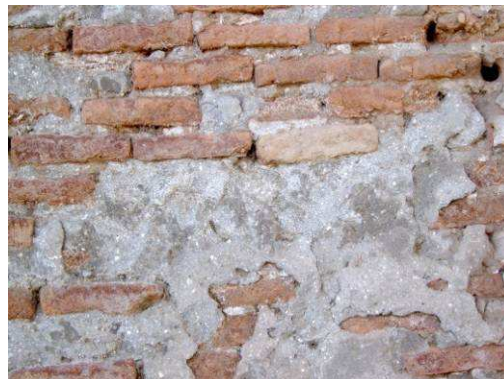
Fig. 7 Cement covering on historical brick (2015)

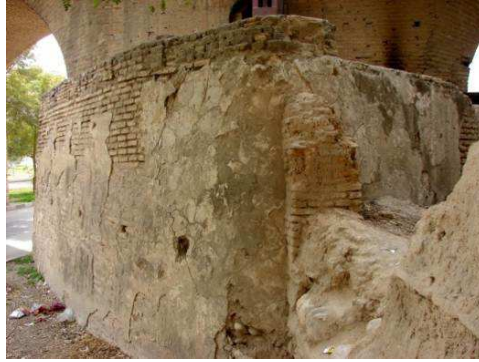
Fig. 8 Wall added to the flow breaker (2015)

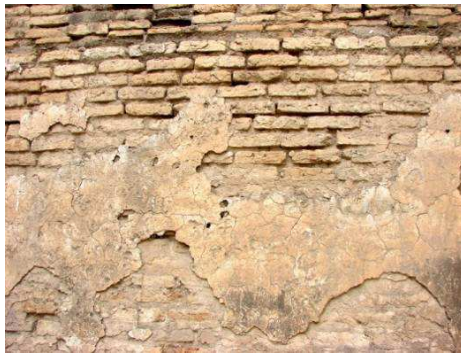
Fig. 9 The crumbling of the filling between the bricks and poor plastering (2015)

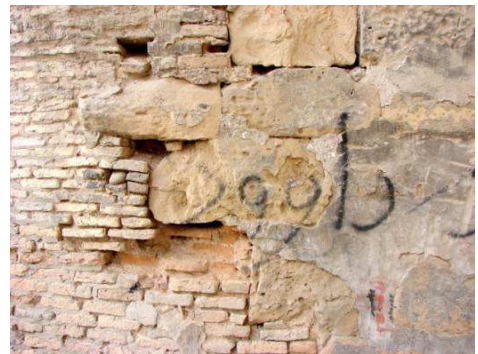
fig. 12 The irregularity of the materials and masonry used(2015)

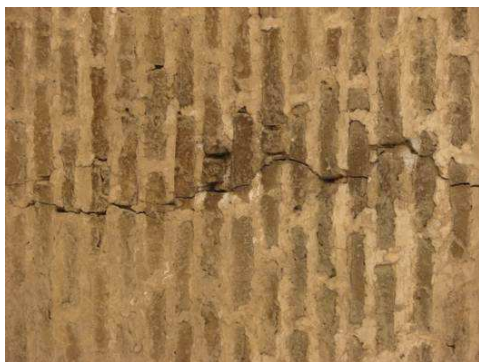
fig. 11 Cracking along the arch joints (2015)

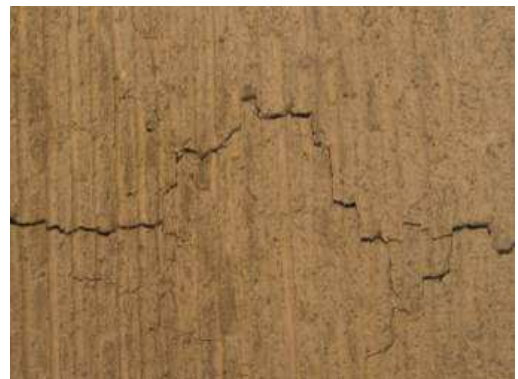
fig. 13 Cracking along the arch joints (2015)

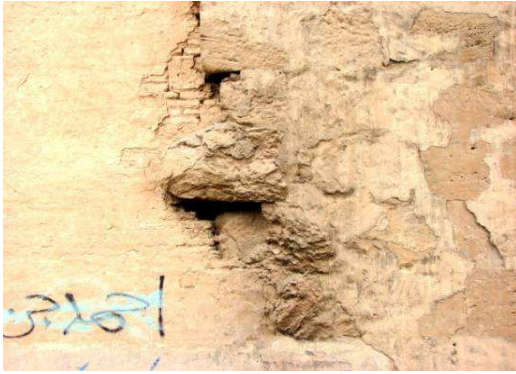
fig. 14 Separation between stone masonry and clay bricks (2015)

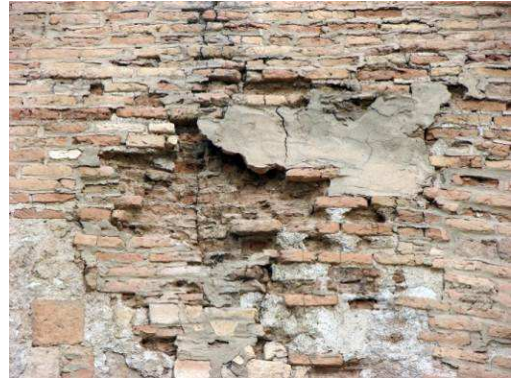
fig. 17 Damage due to the malfunctioning of the water conduit (2015)

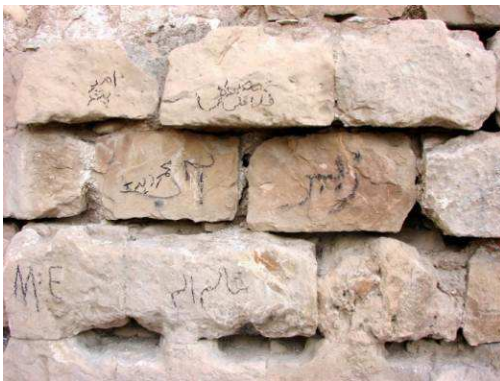
fig. 15 Empty boreholes which were filled with lead clamps

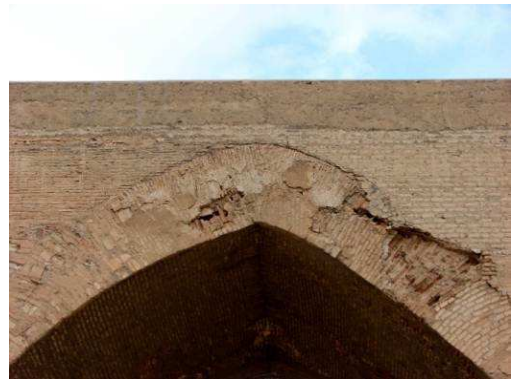
fig. 18 collapse of the upper part of an arch (2015)

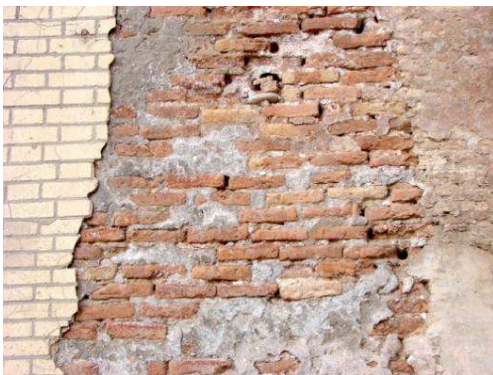
fig. 16 Cement covering with a brick design over the pedestal (2015)

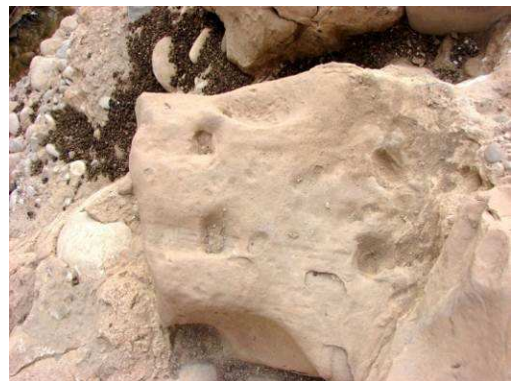
fig. 19 Destruction of the lower foundation stones (2015)

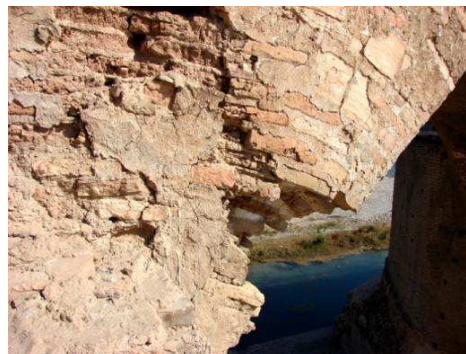
fig.22 Destruction of the arch foundations (2015)

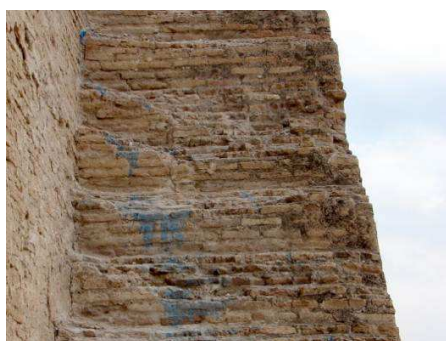
fig. 21 Destruction of the steps(2015)

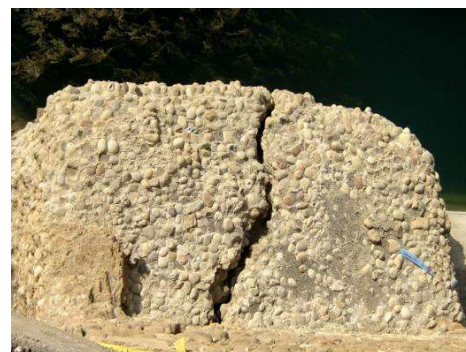
fig. 23 Deep crack in foundation (2015)

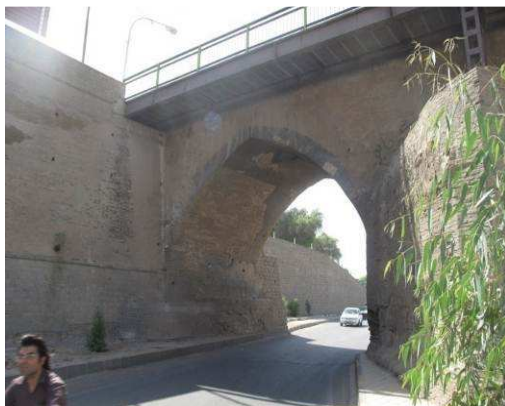
Fig. 25: Application of cement plastering to cover arch cracking (2015)

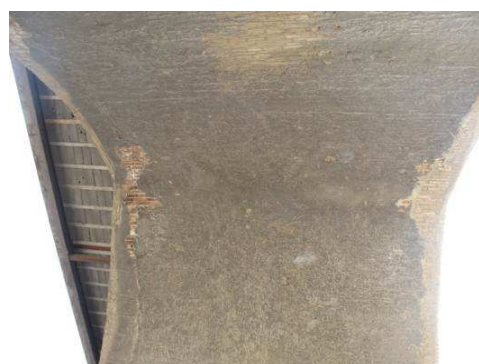
Fig. 26: Repairing of arch using abode brick and cement plastering in recent decades (2015)

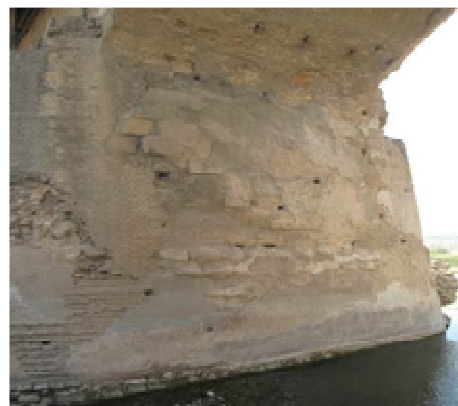
Fig. 27: Remains of scaffolding used for the repairing of the Structure over various periods (source the author-2014)

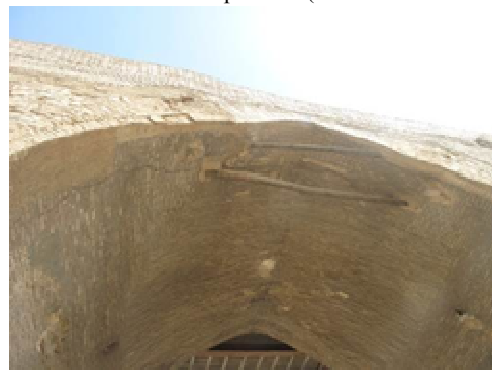
Fig. 28: Remains of scaffolding used for the repairing of the Structure(source the author-2014)

As can be seen in picture 28, in order to decrease the development of the radial cracking in the crown of the arch, wooden supports were utilized. Continuous surface repairs and occasionally major repairs on the pedestals of the bridge had been carried out due to the erosion which had occurred as a result of myriad floods . Picture 27 shows that the repairs occurred over different periods. The repairs whether carried out on the basis of standards or haphazardly have all added to the complexity of the structure's behavior.

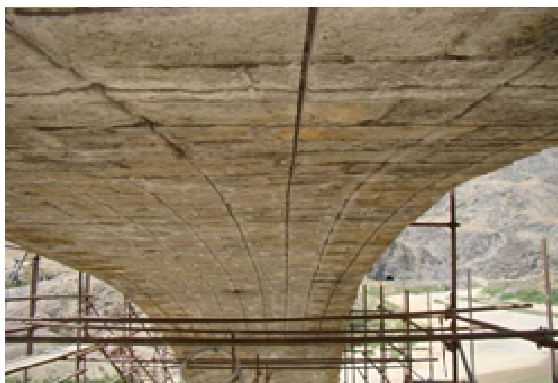
Fig. 31: Sub structural reinforcing of Ghaflankoh railway bridge on Tehran – Tabriz route (source Dez Ab 2011)

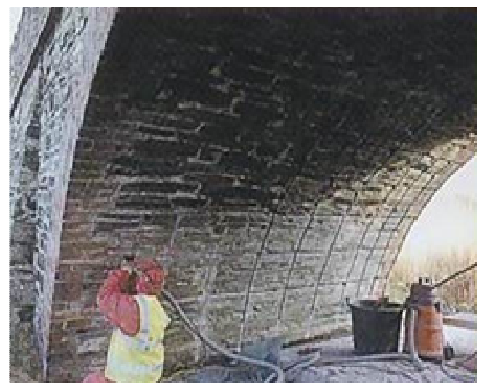
Fig. 32: Sub structural reinforcing using special winding steel rebars in stone and brick arches (source Dez Ab 2011)

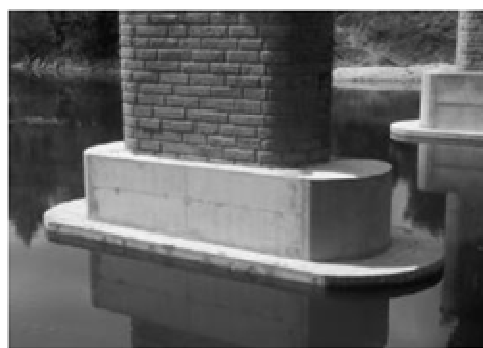
Fig 40: Creating a foundation underwater using an Underpinning method. (Source Dez Ab, 2011)

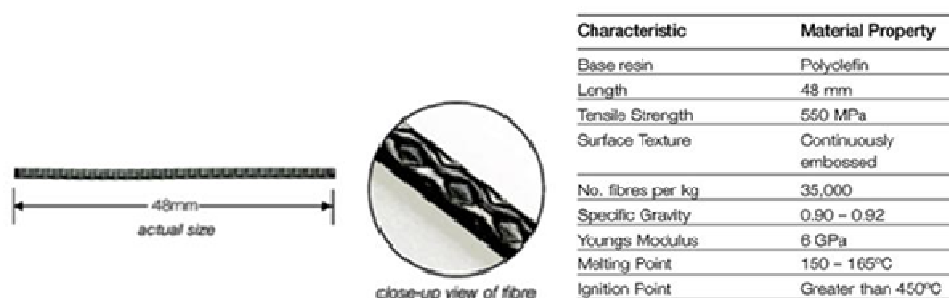
Fig41: Characteristics of polymer threads (source Dez Ab 2011)
