# Review of Different Repairing Methods on Sheet Pile Wharves

**KEYWORDS:** marine and coastal structures, repairing, damage, sheet pile wharf, method

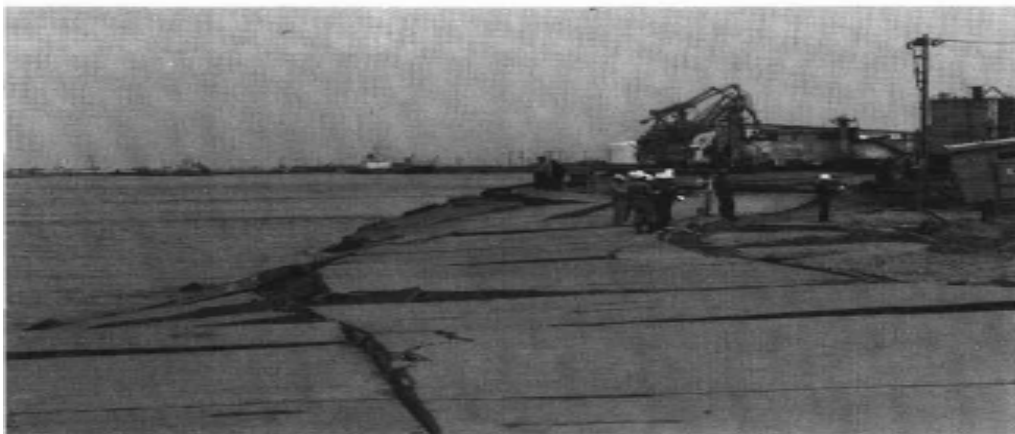
Representative damage to a sheet pile quay wall is shown in Figure 1. This quay wall was located in Akita Port, Japan, and shaken by the 1983 Nihonkai-Chubu earthquake. The damage was mainly due to large pressures applied to the sheet pile wall by the liquefied backfill sand[3,8]. The sheet pile bending moment became excessively large, resulting in the opening of a crack in the wall. This quay wall subjected to ground motions of similar intensity. The anchor was embedded in liquefiable soil, resulting in deformations in the entire wharf. Example indicates that the mode of damage can differ significantly according to the geotechnical and structural conditions of a sheet pile wharf.

**Fig.1.** Damage to a sheet pile quay wall at Shimohama Wharf, Akita Port, Japan, during the Nihonkai-chubu earthquake of 1983.

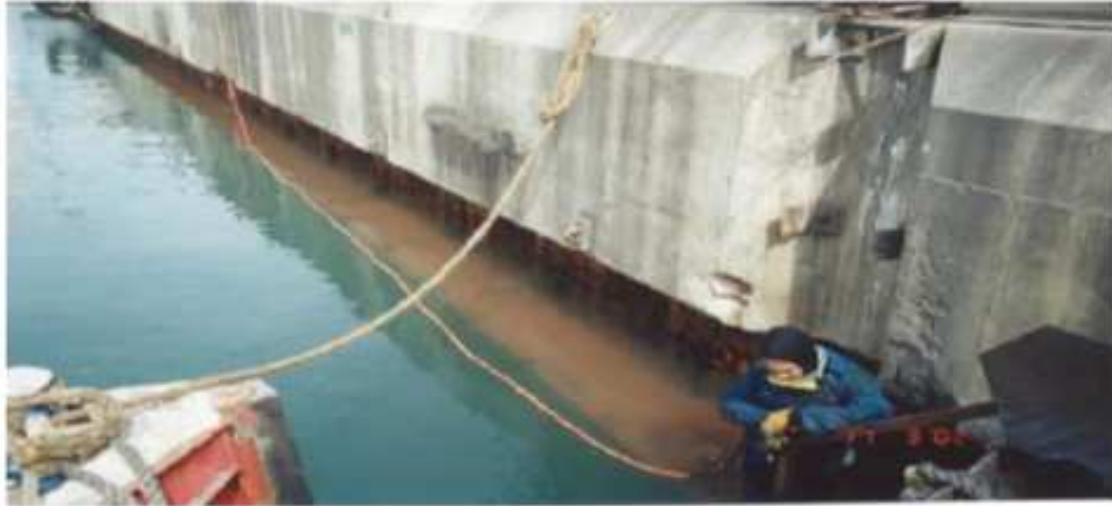
Figures 2 and 3 show the lower and upper part of the form work is mounted to sheet piles in Ashdod project.

**Fig.2.**The lower part of the formwork is mounted to sheet piles

In this wharf, Chernov paid attention to durability and understood that the use of Self-Compacting Concrete(SCC) reinforced with Structural Synthetic Fibre (SSF) helps to eliminate these problems.

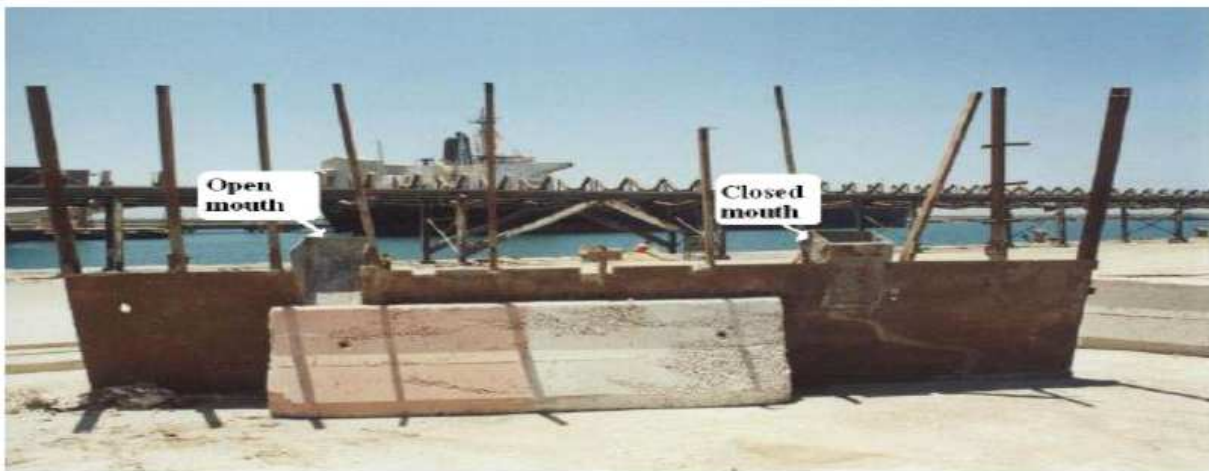
**Fig.3.**The upper part of the formwork is mounted to sheet piles

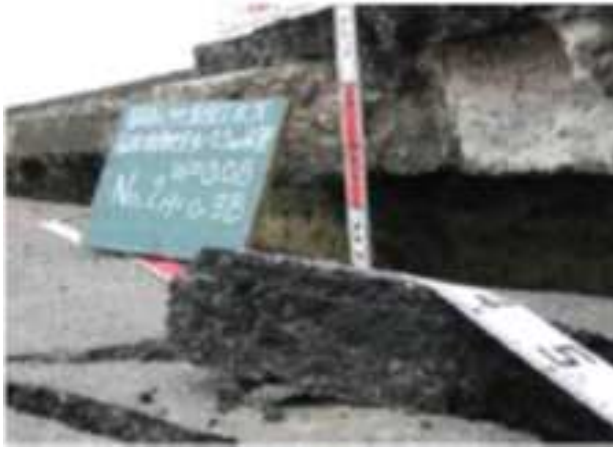
Study in relation to corrosion, as well as impact of the ship and liquefaction is in Khent port[10]. The quay wall was built Z- shaped with copper alloy and iron. In 70 AD, and before the end of 10 years of construction, severe corrosion was found in the sea walls. In 1978, a severe corrosion rate compared with the thickness of plate. 25-year protection strategy is presented with using coating system, adding reinforced steel patch and improving soils with increasing  $\phi$ . Below figures( 4 and 5 ) show the ground settlement in liquefaction and damage to the wharf.

Fig.4.Ground settlement in liquefaction

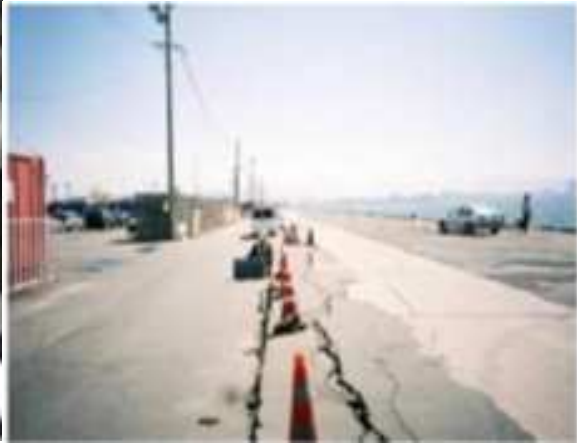
Fig.5. Damage to the wharf

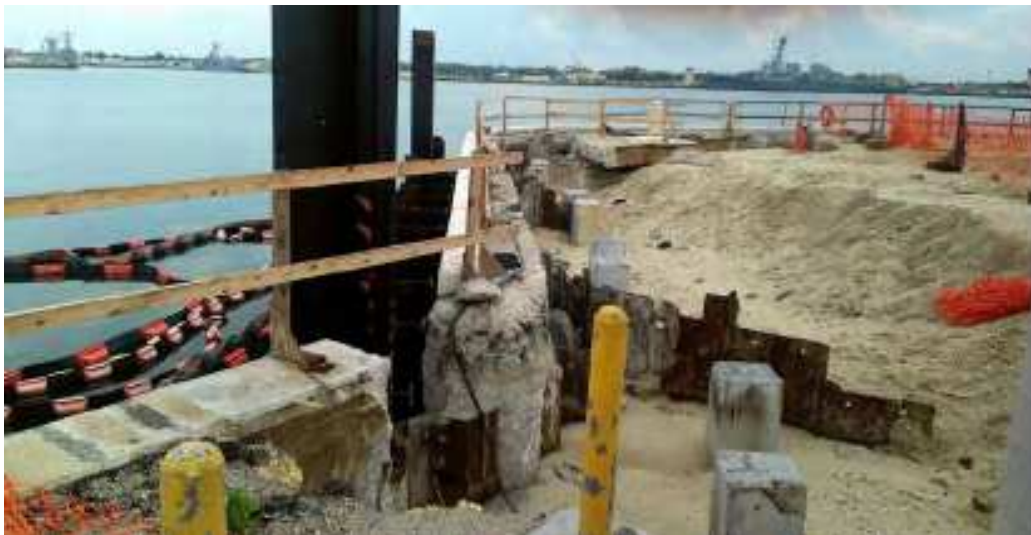
Figure 6 shows partially excavated cell.

Fig.6.Photo of Partially Excavated Cell with Upper Deck Foundation Piles.

The new design consisted of a combination king-pile/sheet pile wall driven outboard of the existing diaphragm wall, with the space between the two backfilled with flowable concrete fill. The design primarily utilized traditional limit-equilibrium methods to design the wall ignoring the effects of the existing structural elements. However, given the complex behavior of the existing elements with the new wall system, advanced continuum soil analyses were also conducted to better understand the behavior of the complex system and confirm acceptable performance.
